# RQL Sector Rig Testing of SiC/SiC Combustor Liners

Michael J. Verrilli and Lisa C. Martin  
Glenn Research Center, Cleveland, Ohio

Combustor liners, manufactured from silicon carbide fiber-reinforced silicon carbide, (SiC/SiC), were tested for 260 hrs using a simulated gas turbine engine cycle. This report documents the results of the last 56 hours of testing. Damage occurred in one of the six different components that make up the combustor liner set, the rich zone liner. Cracks in the rich zone liner initiated at the leading edge due to stresses resulting from the component attachment configuration. Thin film thermocouples and fiber optic pyrometers were used to measure the rich zone liner's temperature and these results are reported.

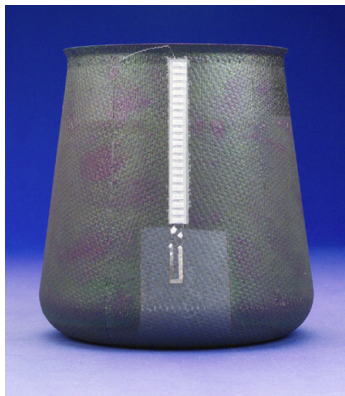
Figure 4 – Photograph of a thin film thermocouple installed on a rich zone liner.

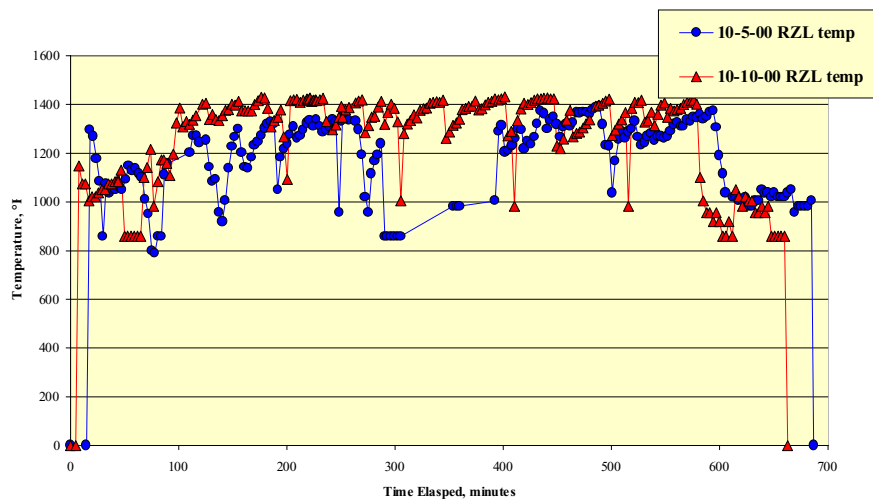
Figure 13 – Rich zone liner temperature measured during sector rig testing.

7.3.1 Fiber Optic Pyrometry Data – Figure 13 shows the temperature of a RZL versus time measured during two of the test runs. The temperature was measured 3.5 in. aft of the fuel/air nozzle and was obtained during the fourth and fifth test runs, when the second set of RZLs was installed. Note that the pyrometry system is not accurate below about 850 °F.

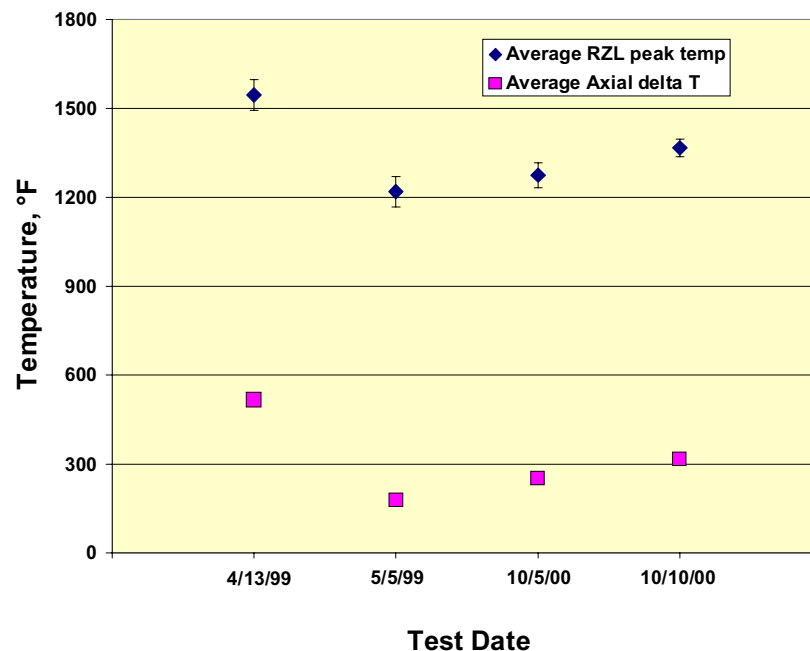
The average peak temperature measured during the supersonic cruise portion of the cycle is shown in Figure 14. Data obtained during the current study is shown along with some temperature data obtained during the previous 205 hours of testing. The maximum rich zone liner temperatures measured during the current study are within the range obtained during previous sector testing. Figure 14 also shows the axial temperature gradient, which is the difference between the average peak liner temperature and the combustor inlet air temperature, T3. The leading edge of the RZLs is cooled by the inlet air and therefore is at the same temperature. The axial gradients vary from 175 to 515 °F.

Figure 14 – Average peak temperature of rich zone liners measured during the supersonic cruise portion of the test cycle and calculated axial delta T as a function of test date.

The most critical aspect of material performance under the combustion environment is managing the thermal stresses (refs. 8–9). Liner temperature measurements indicated that a thermal gradient exists along the flow direction during operation (Figure 14). The gradient is based on temperatures measured along one linear section of the RZLs. It is likely that temperatures varied around the circumference of the liners, as a variation in oxide color (and therefore oxide thickness) was generally observed in tested RZLs (Figure 11). The presence of carbon deposits on the ID (Figure 12) likely affected the liner temperatures. Also, the thermal stresses, that are most important to design of the liners, are due to through-thickness temperature gradients. Thus, it is possible that the data in Figure 14 represents a lower bound for temperature gradients that would be critical to liner durability.

As part of this study, modifications of the fuel/air nozzles were made in an attempt to reduce the flow of by-pass air into the combustion stream and thus reduce the axial thermal gradient in the RZLs. The fuel/air nozzles contain seals that were designed to minimize the by-pass air flowing into the combustor. The presence of by-pass air in the combustion flow cools the upstream portion of the RZLs, but does not affect the temperature in the hottest portion of the liner, the aft end. This was verified with pyrometry data from tests conducted in 1999. The axial temperature gradients measured during tests conducted in 1999 bounds the gradients measured during the present study (Figure 14). Thus, the modifications of the fuel/air nozzles did not reduce the thermal gradients along the flow direction.

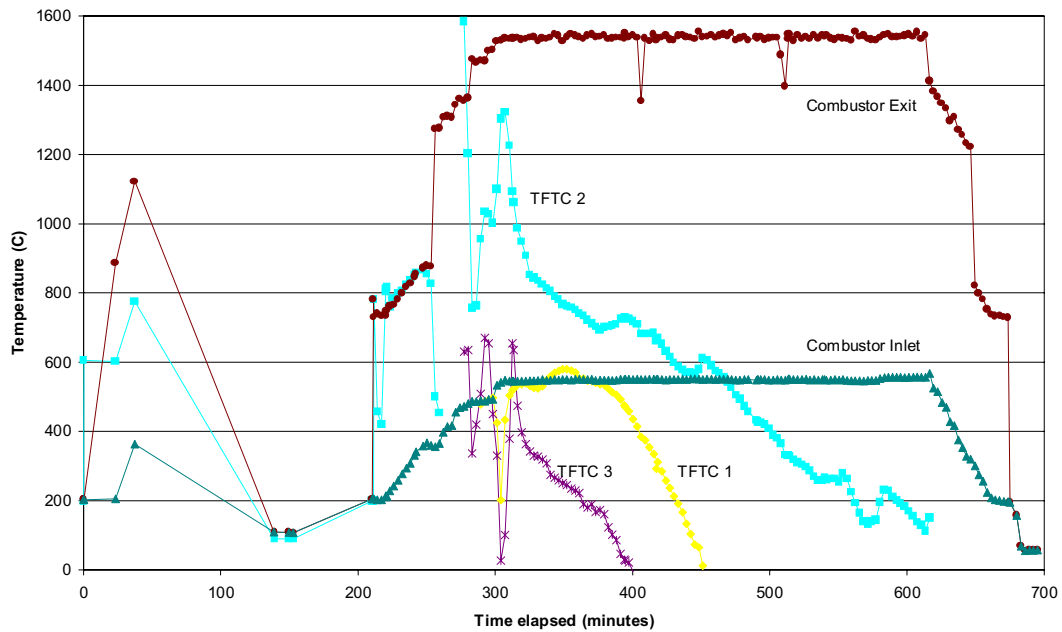
**7.3.2 Thin Film Thermocouples** – The RZLs instrumented with thin film thermocouples were exposed to room temperature air for approximately 220 minutes and heated air for approximately 210 minutes flowing about 2 lbs/s prior to the combustor being lit. This exposure was due to facility problems that prevented the initiation of testing. Only a few temperature data points were recorded during this period, however, the thin film thermocouple data obtained during this time indicated that the material surface temperature was between the combustor inlet and combustor exit temperatures. Once the combustor was lit, the thin film thermocouple output was erratic as the temperatures were increasing. The output of two thin film thermocouples and the combustor inlet and exit temperature data are shown in Figure 15. The thermocouple data eroded with time after exposure to the elevated temperatures.

Figure 15 – Thin film thermocouple data obtained during sector rig testing.

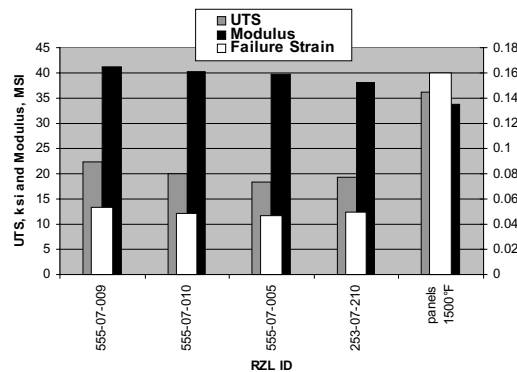
As part of the characterization of the as-manufactured RZLs, the hoop tensile properties were measured. A hydrostatic ring test facility was used to test two witness coupons from each component at room temperature (ref. 11). The strength, modulus, and strain to failure for the four rich zone liners are compared to data obtained from plate specimens machined from the same vintage material in Figure 17. On average, the rich zone liner witness coupons had 45% lower strength, 70% lower failure strain, and 20% higher modulus than the plate specimens. Thus, the properties indicate that the rich zone liner composite was more brittle and weaker than material in plate form. Note that panel data was the basis for the component design.

Quality of material may have contributed to the severity of damage observed. The as-manufactured components were ranked based on NDE results, mechanical and thermal properties from witness coupons, and microstructural quality. The highest rated rich zone liners were selected for initial rig testing. Three sets of RZLs (six total) were tested during the first 205 hours of sector rig operation in 1999. The first set failed catastrophically due to design issues with the attachment system. The other two sets of RZLs tested in 1999 did develop cracks, but had less damage (in terms of total crack length) and were tested longer (65 and 80 hrs) than those tested in this study. The four RZLs discussed in this paper were

Figure 17 – As- manufactured strength, modulus, and failure strain obtained through ring burst tests for the rich zone liners exposed in the sector rig.

ranked lower than the six tested in 1999. In particular, the last PL-side RZL (253-07-210) that failed (Figure 10) had the lowest rank of the ten.
